U.S. DEPARTMENT OF
ENERGY

Legacy
Management

2021 Annual Site Inspection and Monitoring Report for Uranium Mill Tailings Radiation Control Act Title II Disposal Sites

December 2021

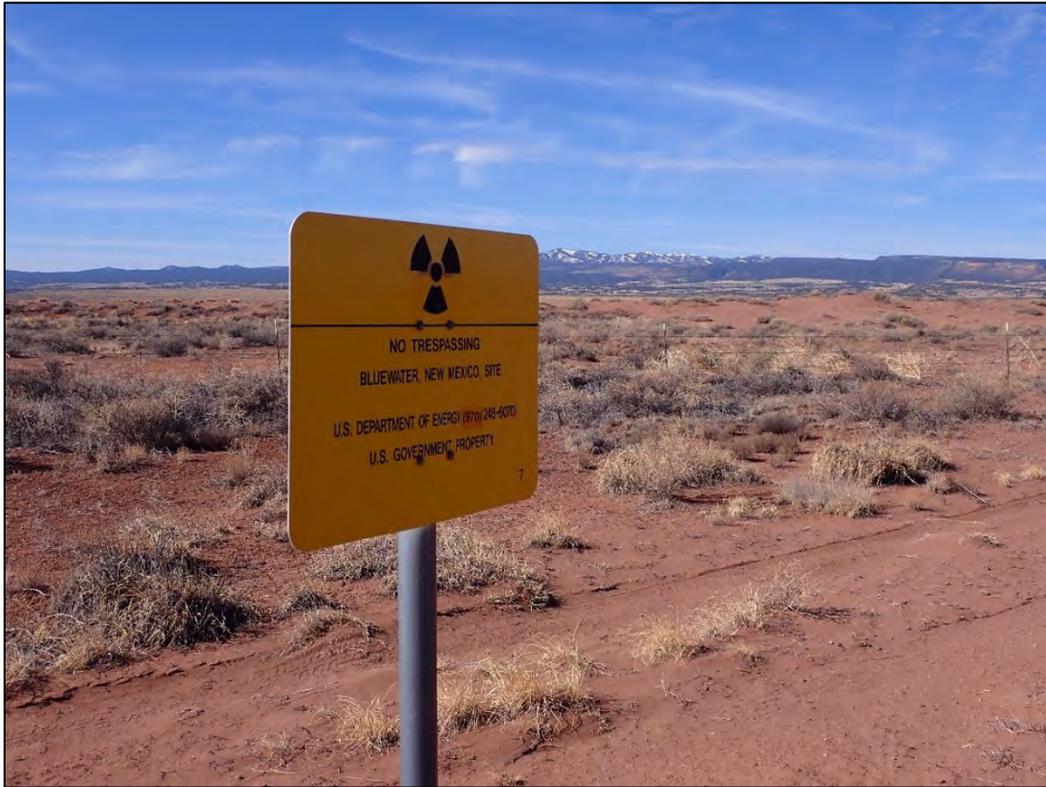
PL-5. Perimeter Sign P7

Fifty-five perimeter signs (warning and no-trespassing signs) are mounted on steel posts along the site boundary and around the main and carbonate tailings disposal cells (PL-5). Perimeter sign P8 was out of the ground (PL-6) and the base of perimeter sign P16 was loose (PL-7); both were repaired in a subsequent maintenance trip. Perimeter signs P3 and P10 have bullet hole damage but are legible. No other maintenance needs were identified.

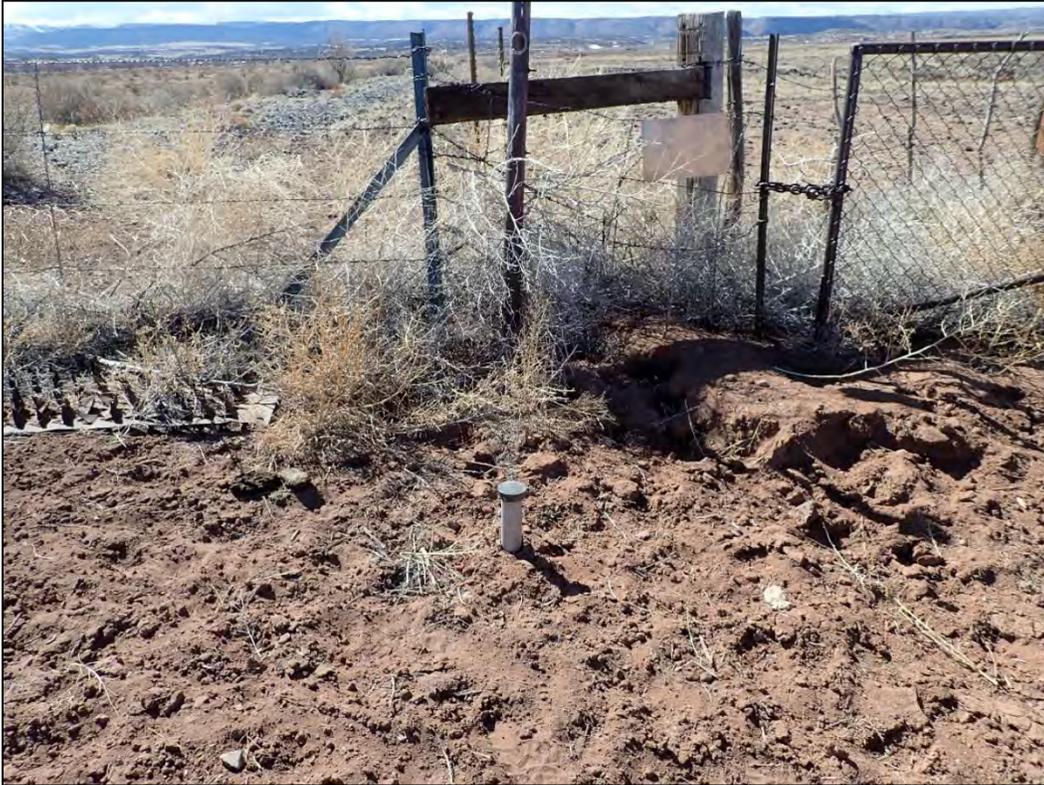
PL-9. Boundary Monument BM-2

Twenty-four boundary monuments define the site boundary (PL-9). These monuments are typically inside the perimeter fence and several feet inside the true corner or boundary line. Some monuments become covered by drifting sand, and metal T-posts have been driven at those locations to help inspectors find them. Other monuments are in remote sections of the site and cannot be observed from site access roads. All boundary monuments were inspected during the 2021 inspection. No maintenance needs were identified.

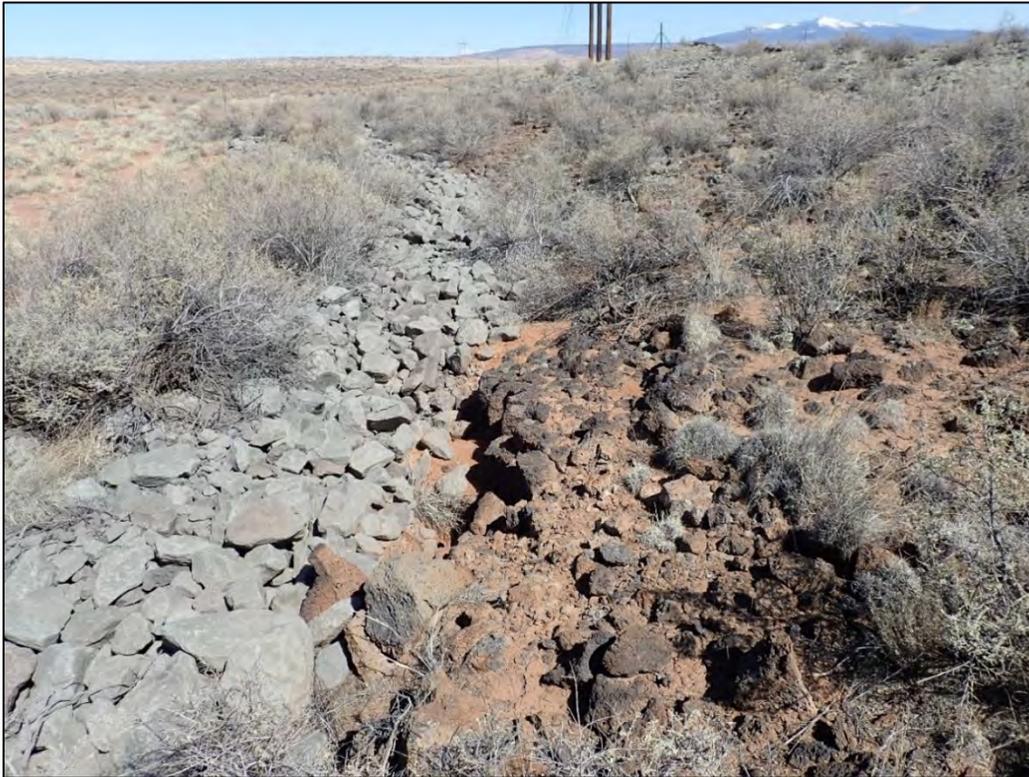
PL-23. Settlement Along Natural Basalt and Limestone Riprap Interface at East Dump

PL-19	0	Rilling North of Perimeter Sign P24
PL-20	330	Shallow depression on the Northwest Extension of the Carbonate Tailings Disposal Cell (Dry)
PL-21	180	Asbestos Disposal Area
PL-22	0	West Dump (Grass Cover)
PL-23	75	Settlement Along Natural Basalt and Limestone Riprap Interface at East Dump
PL-24	65	Ephemeral Pond Area (Dry)

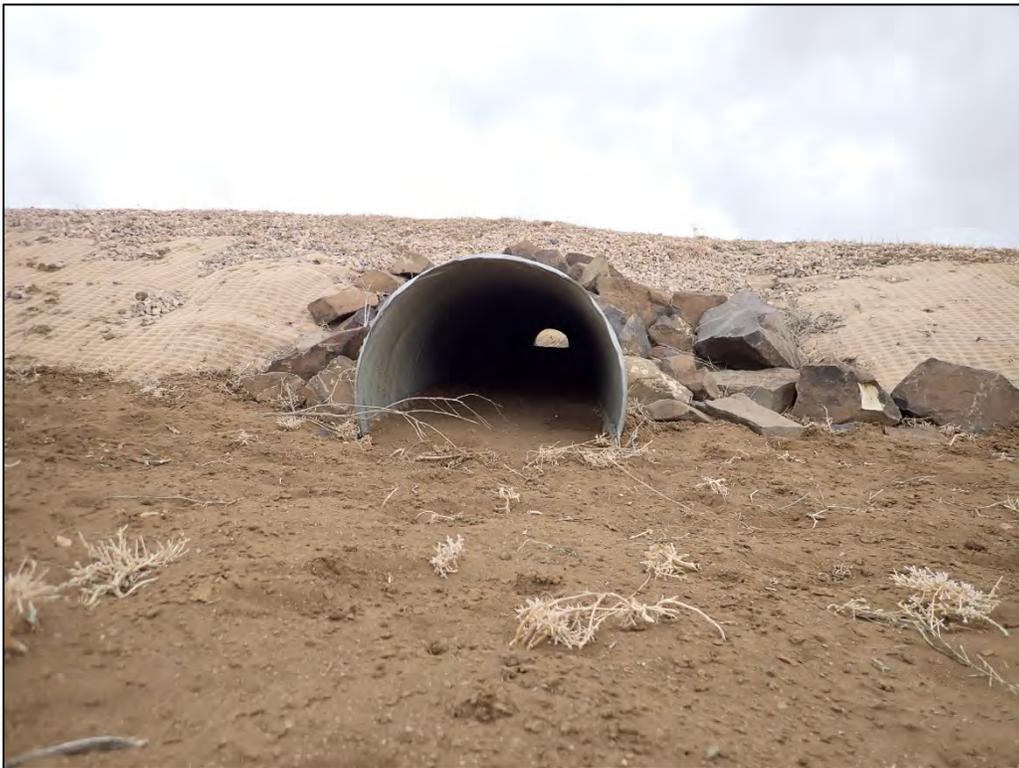
PL-2. Sedimentation in Eastern-most Culvert (Installed in 2016)

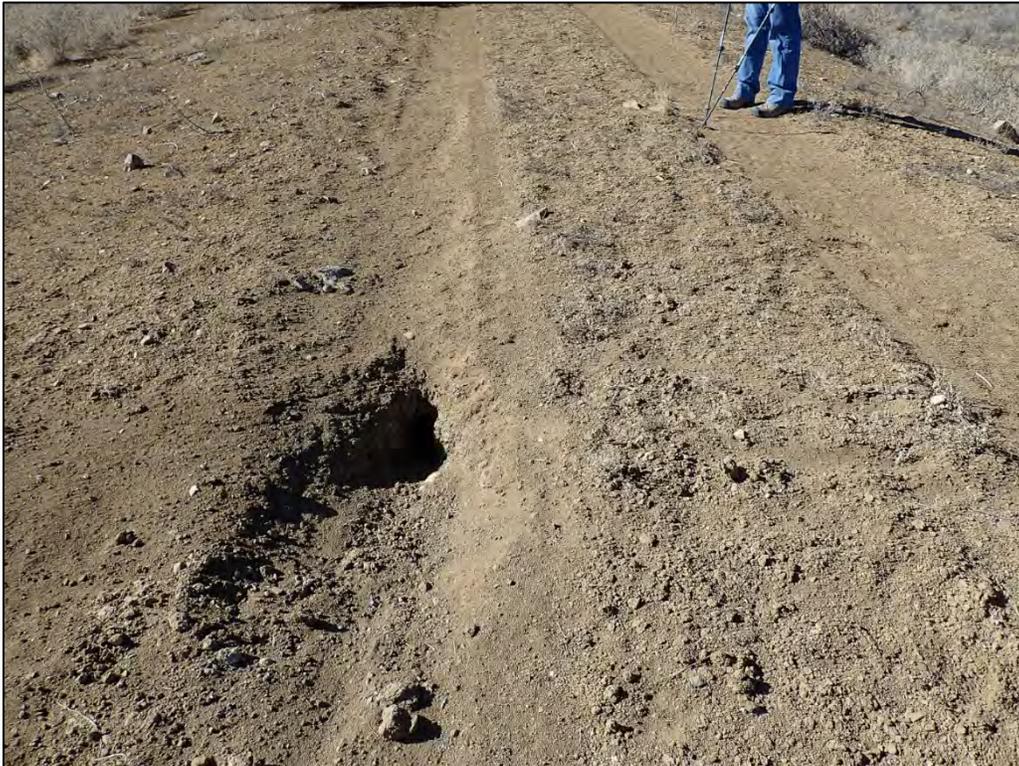
PL-3. Animal Burrow on Access Road

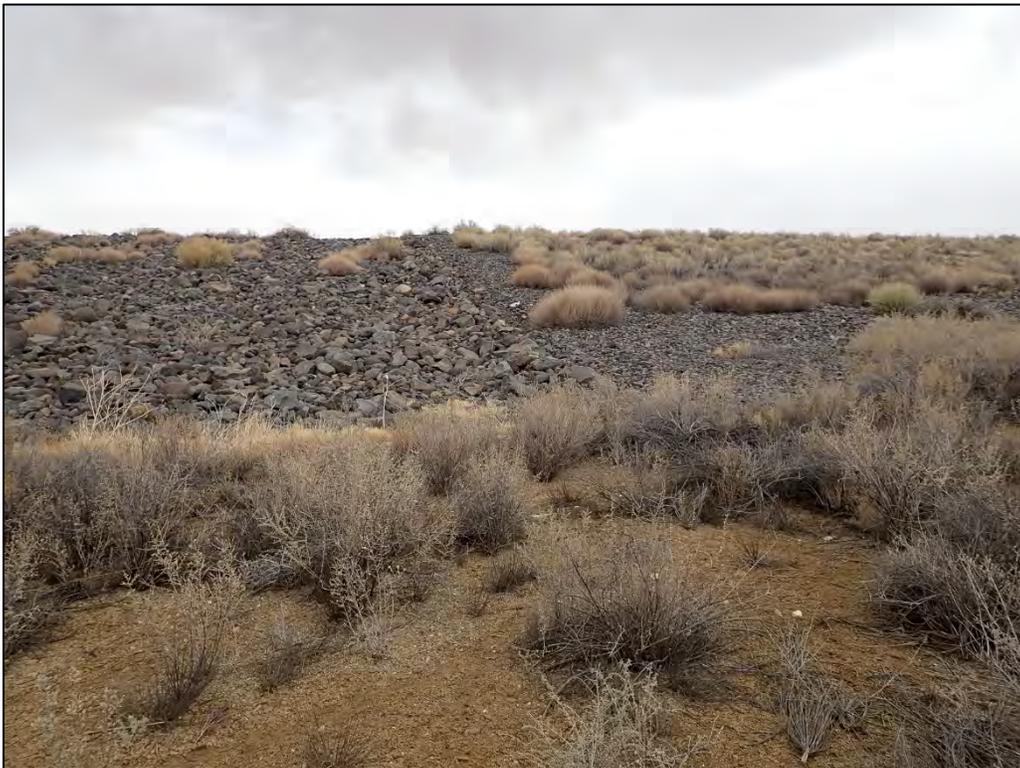
PL-12. Potential Stormwater Flow Path Along Containment Dam Spillway

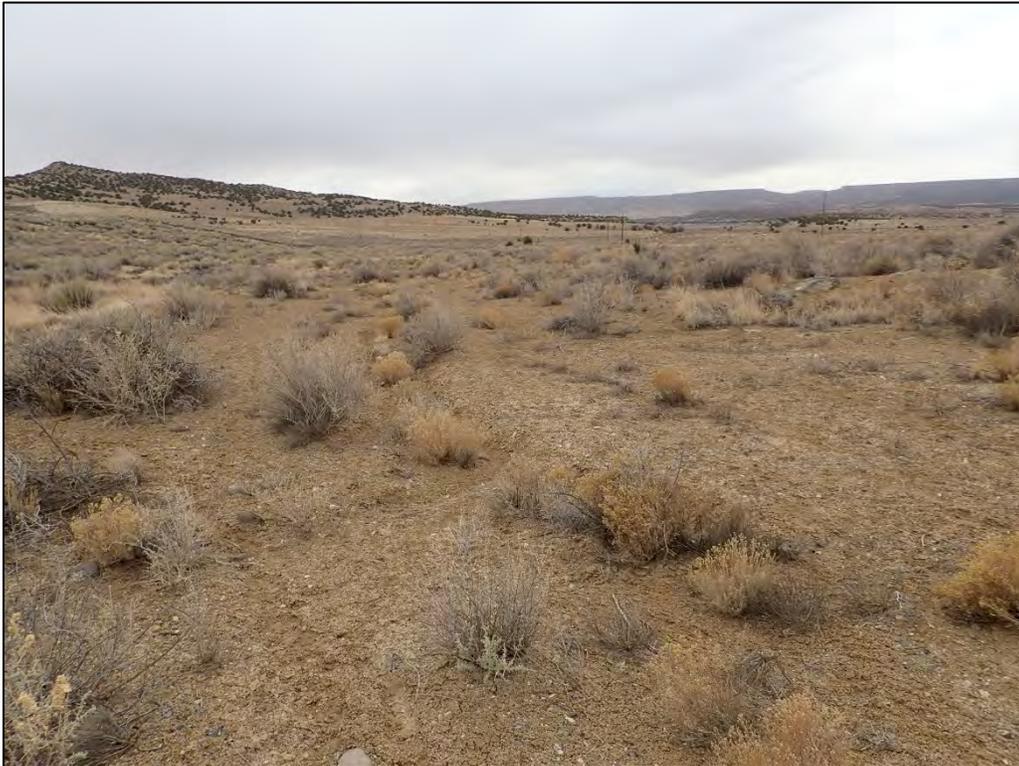
PL-16. Minor Rilling Near North Channel Cutoff Wall

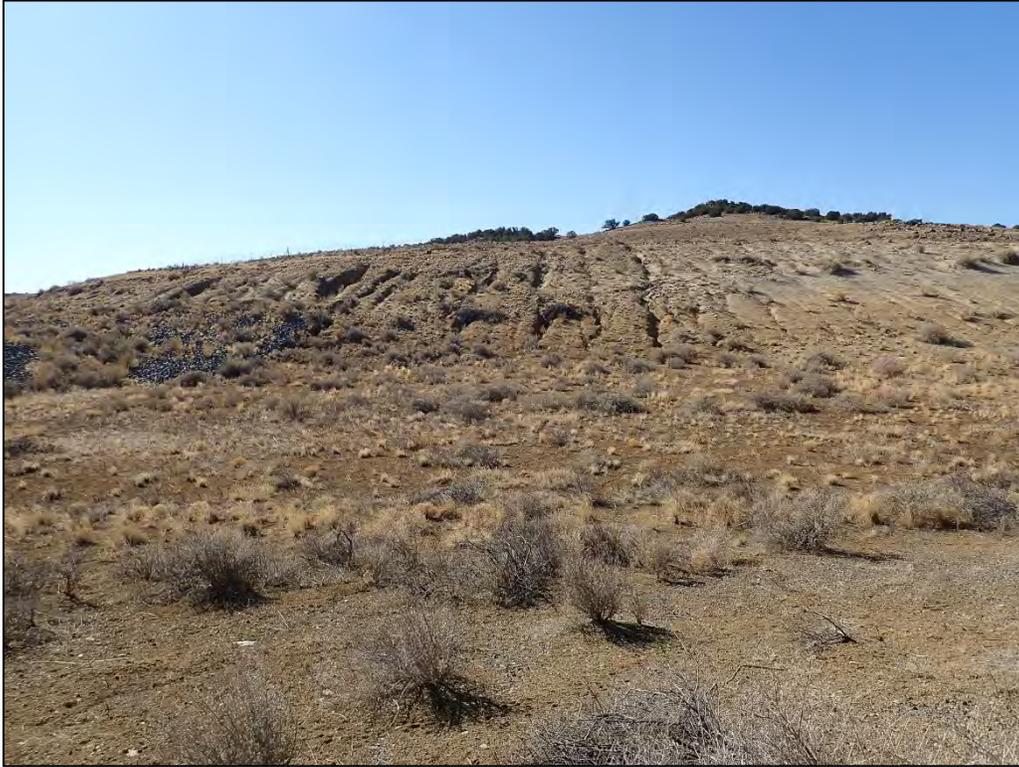
PL-17. Erosion on South Side Slope of South Diversion Channel

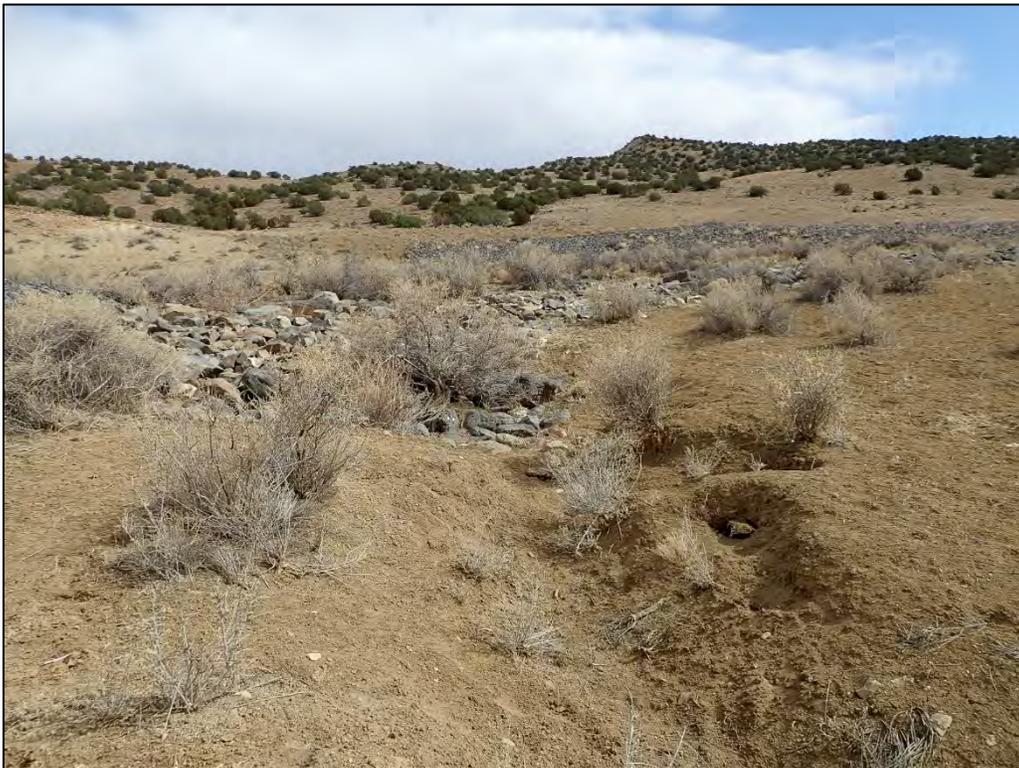
PL-18. Minor Rilling Downgradient of South Diversion Channel Cutoff Wall

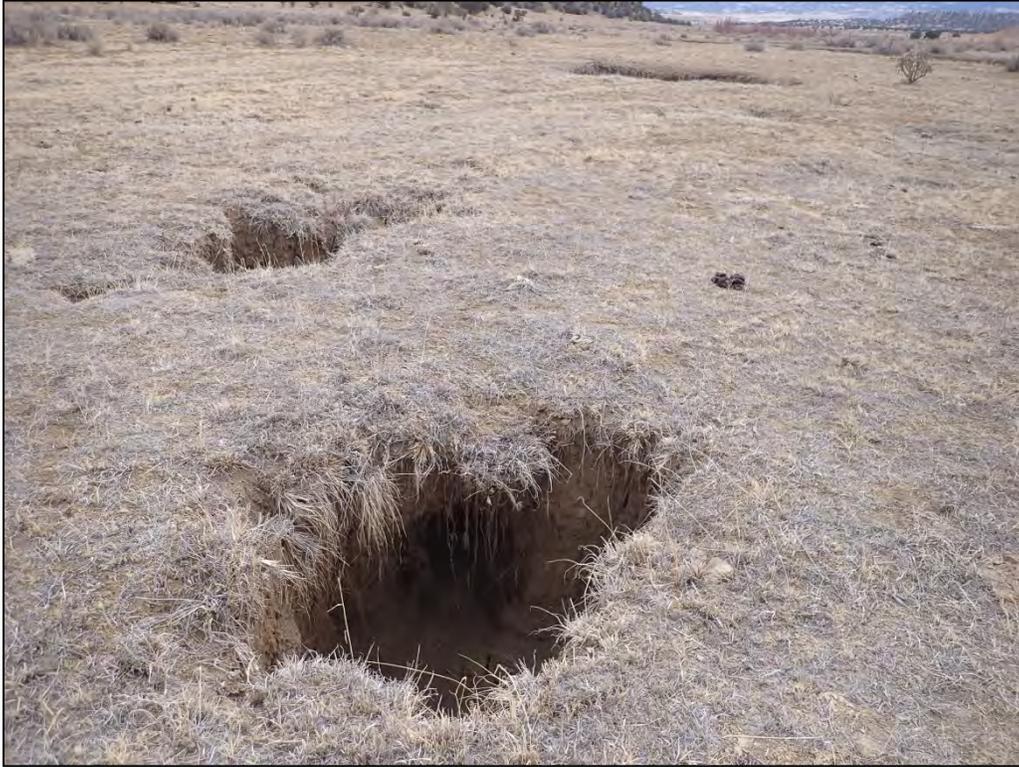
PL-19. Soil Piping Near Southwest Corner of Site Boundary

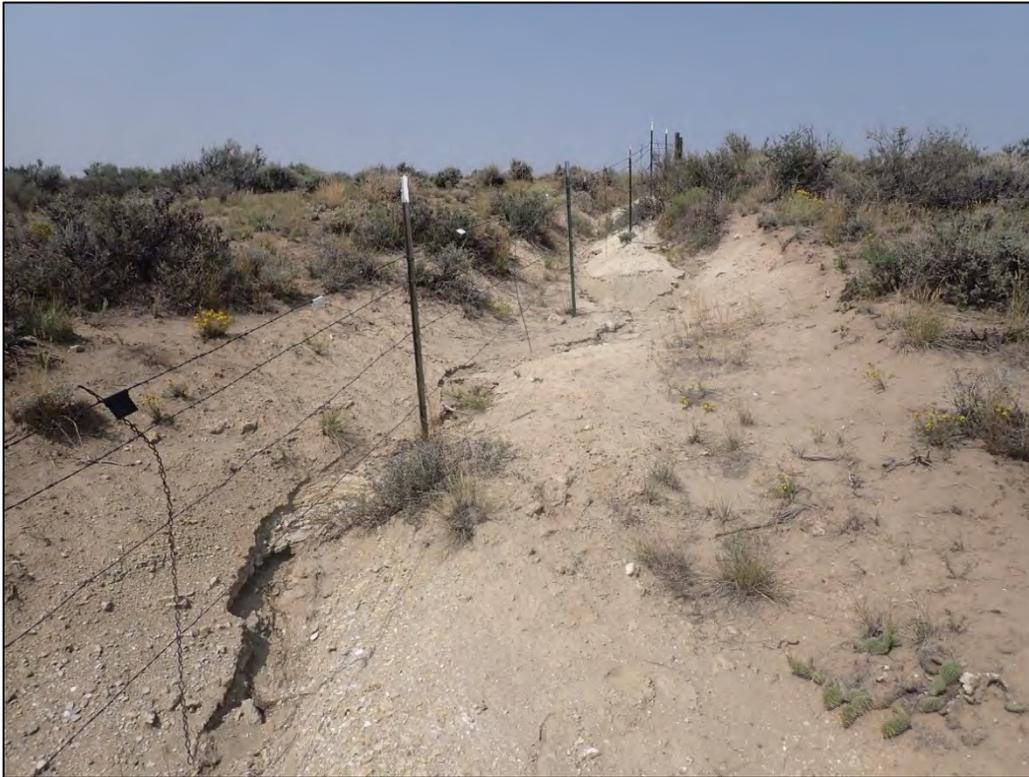
Gullies were observed west of Diversion Channel No. 2, and slight rilling under the northern and southwestern perimeter fence was also observed. None of this erosion threatens the integrity of the main disposal cell, ancillary cell, or associated surface water diversion structures; monitoring of this erosion will continue. No new observations or maintenance needs were identified for 2021. Inspectors identified no cause for a follow-up inspection. Groundwater monitoring is not required at the site.

PL-1. Erosion Under the Perimeter Fence Southwest of the Disposal Cell

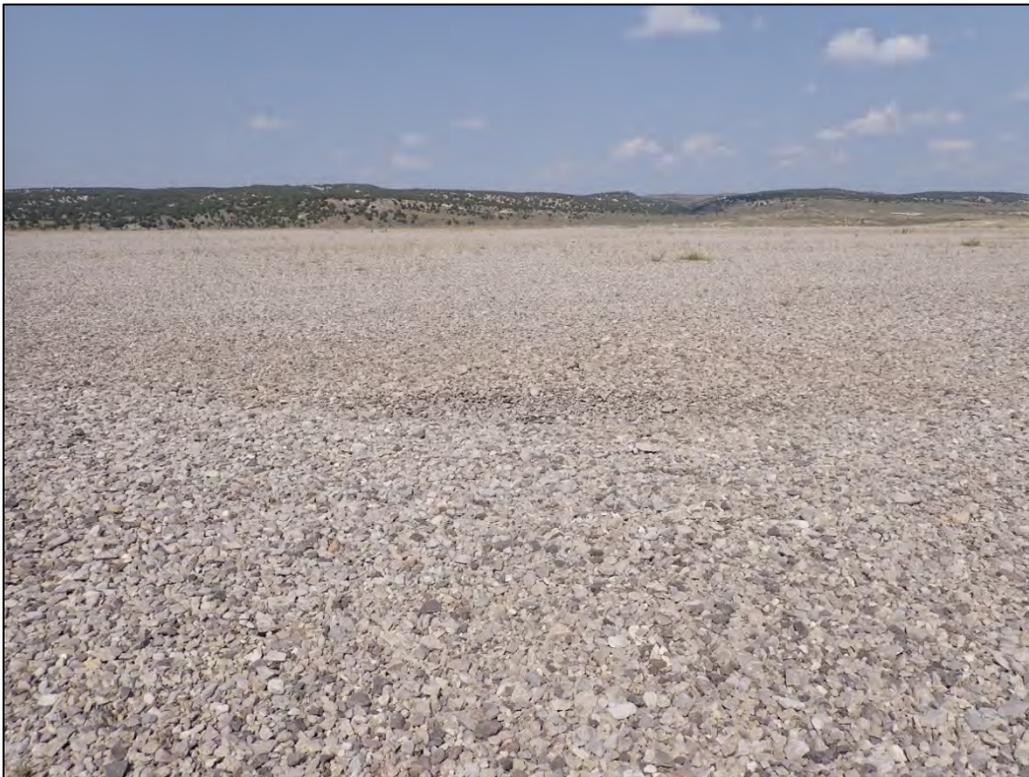
No standing water was observed in any of the depressions during the inspection. These depressions currently do not threaten the integrity or performance of the disposal cell. No maintenance needs were identified.

PL-8. Shallow Depression No. 1

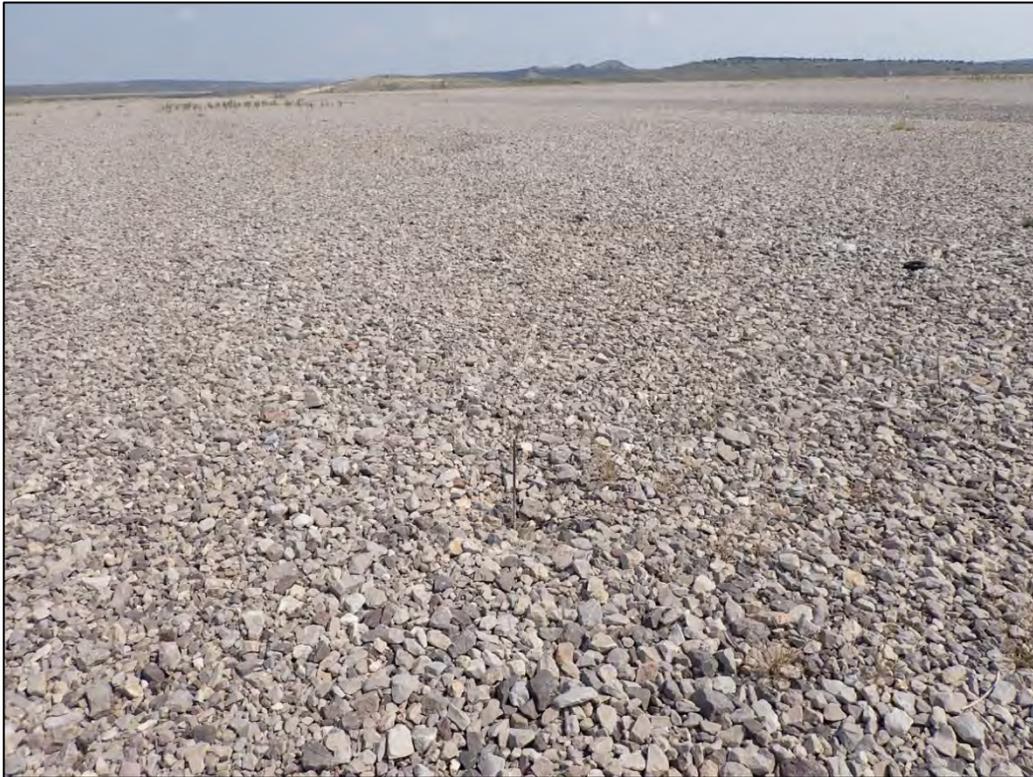
PL-9. Shallow Depression No. 3

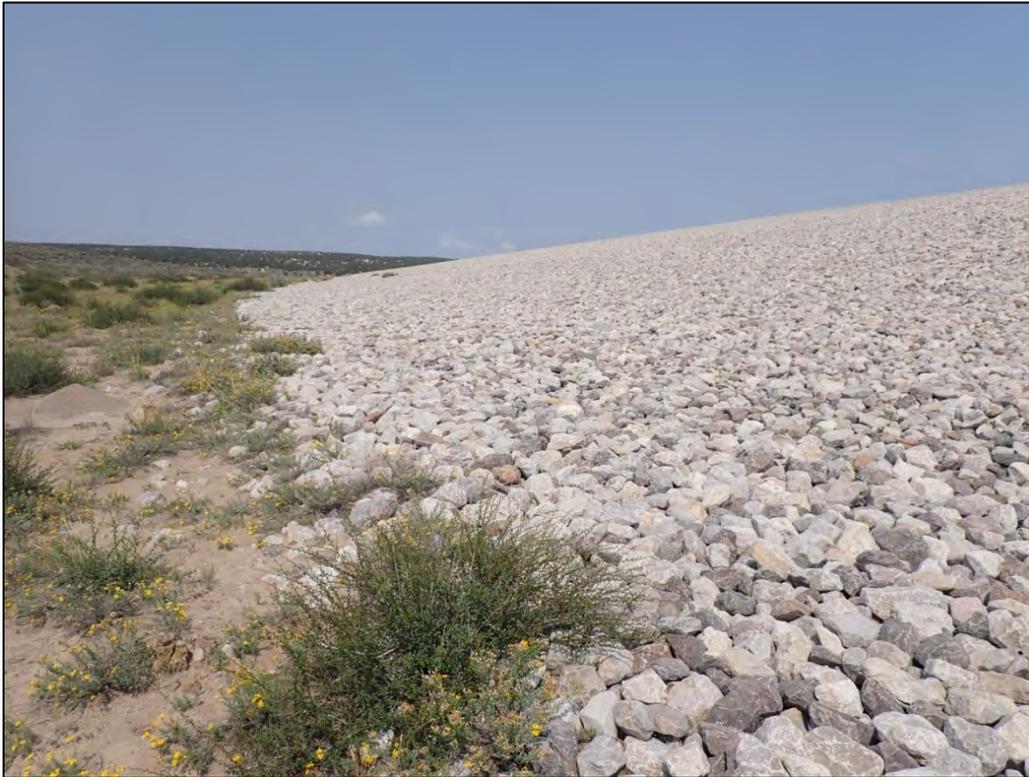
PL-11. Windblown Material Along Western Toe Slope of Disposal Cell

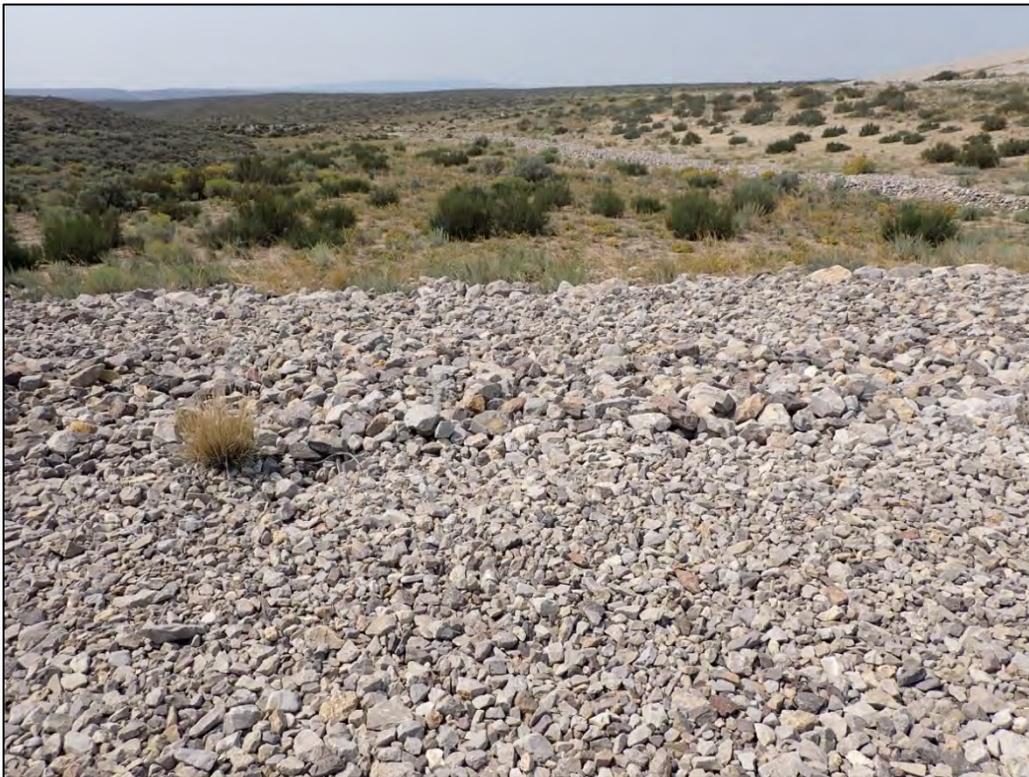
PL-14. Small Depressions on Ancillary Cell Top Slope

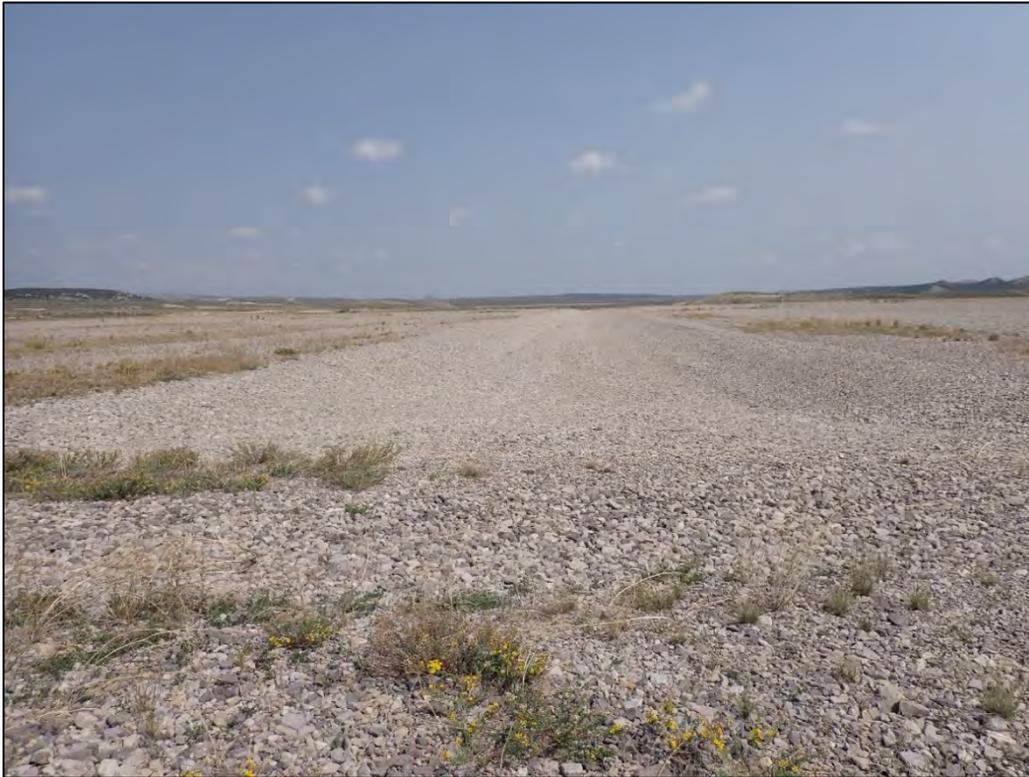
PL-15. View East of Diversion Channel No. 1

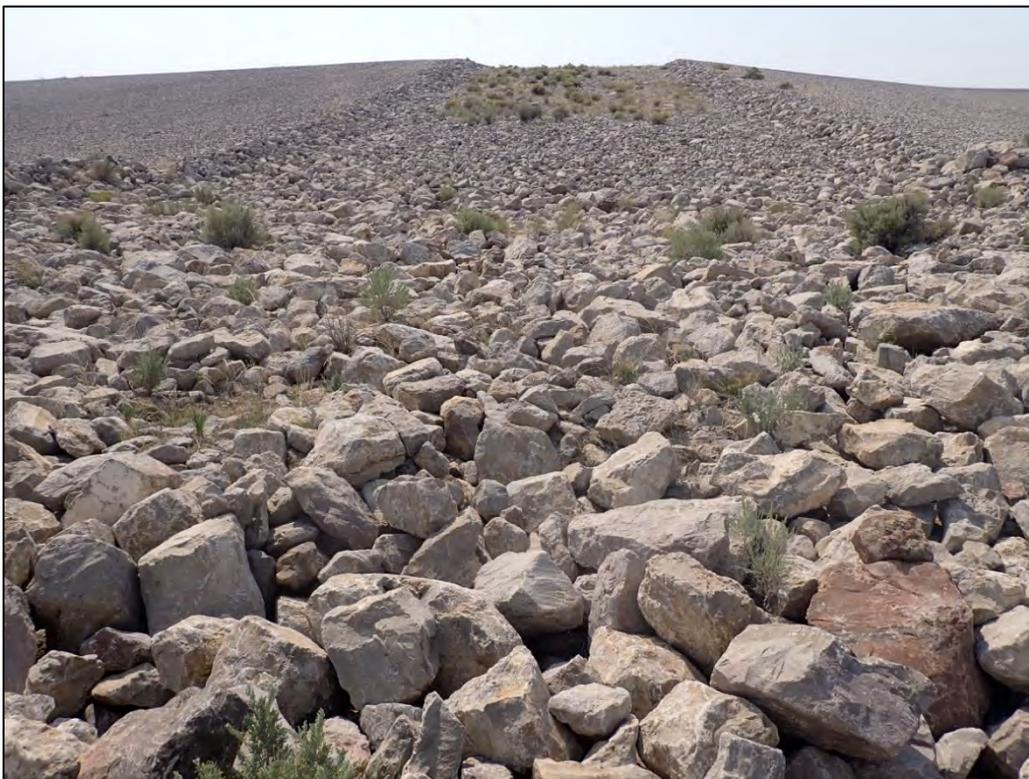
PL-16. View Southwest of the Launch Rock Erosion Protection Basin

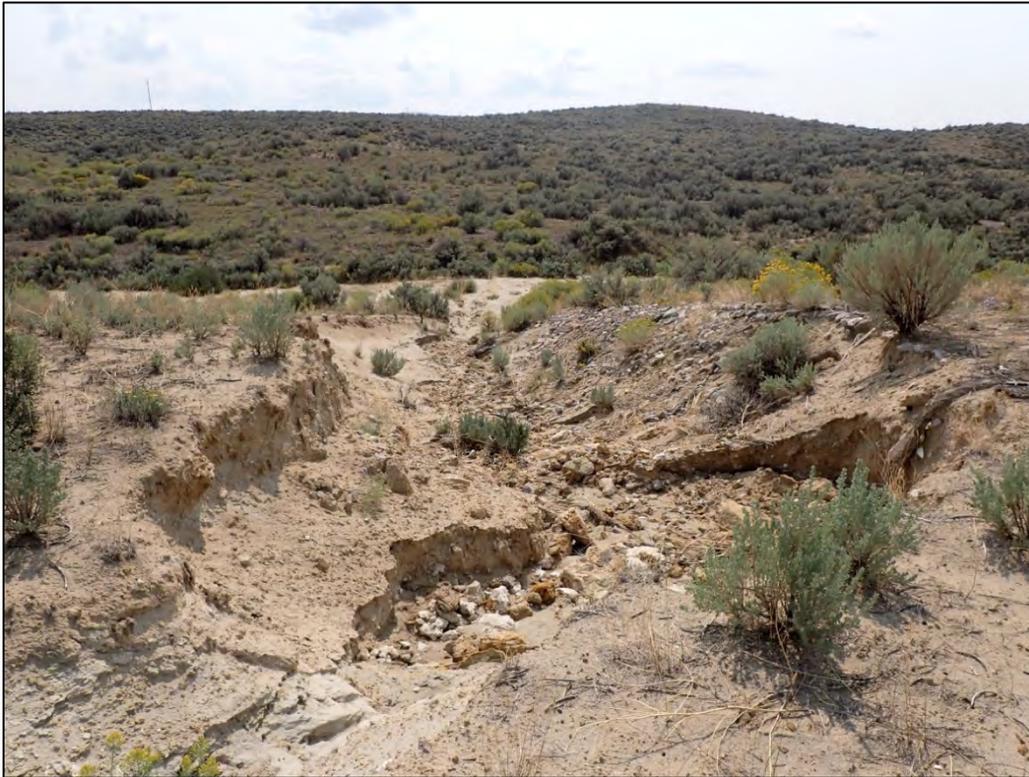
PL-17. Erosion South of Rock Berm Near Diversion Channel No. 2

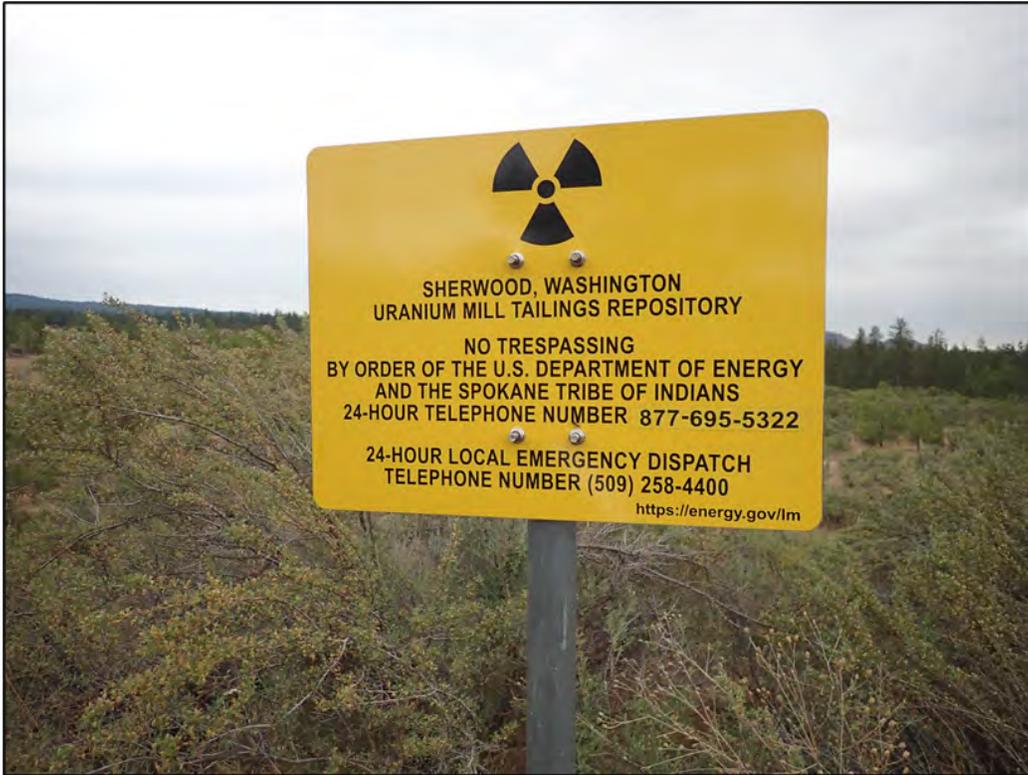
There are six warning or perimeter signs, attached to steel posts set in concrete, positioned along the site boundary at likely access points around the site (PL-1). Perimeter sign P2 was missing and was replaced during the subsequent groundwater sampling event in July 2021. No additional maintenance needs were identified.

PL-1. Perimeter Sign P6

Perimeter sign P2 was identified as missing and was replaced during the subsequent groundwater sampling event in July 2021. No additional routine maintenance needs were identified.

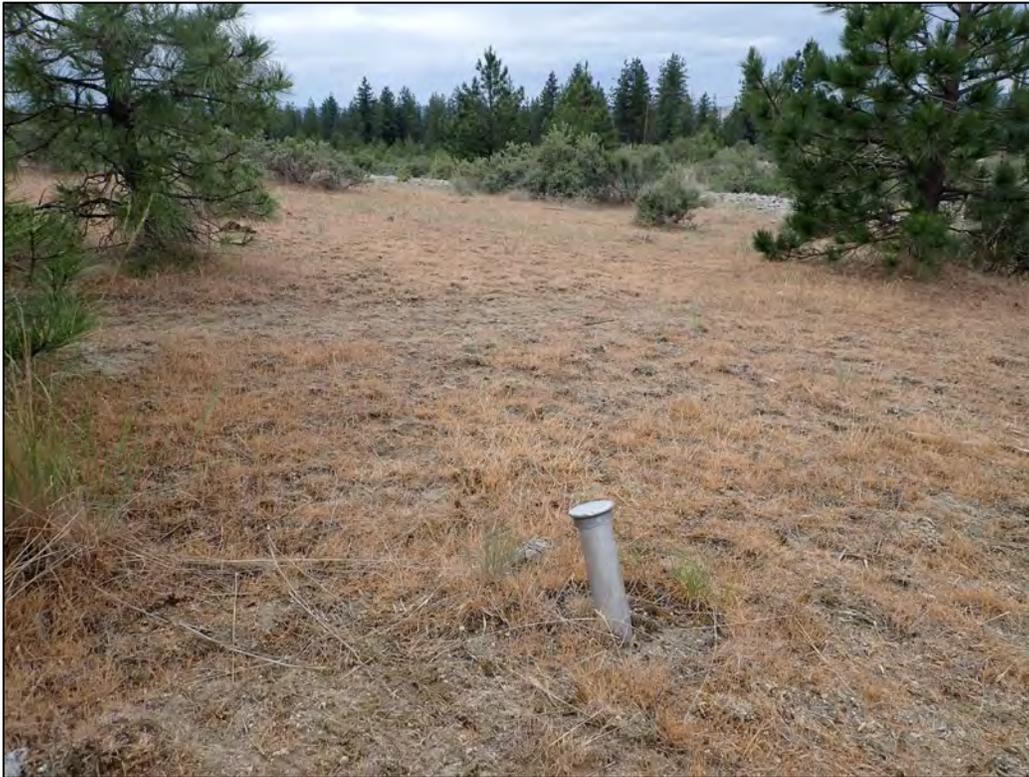
Six boundary monuments set in concrete define the site boundary. Because surrounding vegetation has made it difficult to locate some of the monuments, metal T-posts were installed at each monument location (PL-3). All boundary monuments were inspected. No maintenance needs were identified.

PL-3. Boundary Monument BM-3A

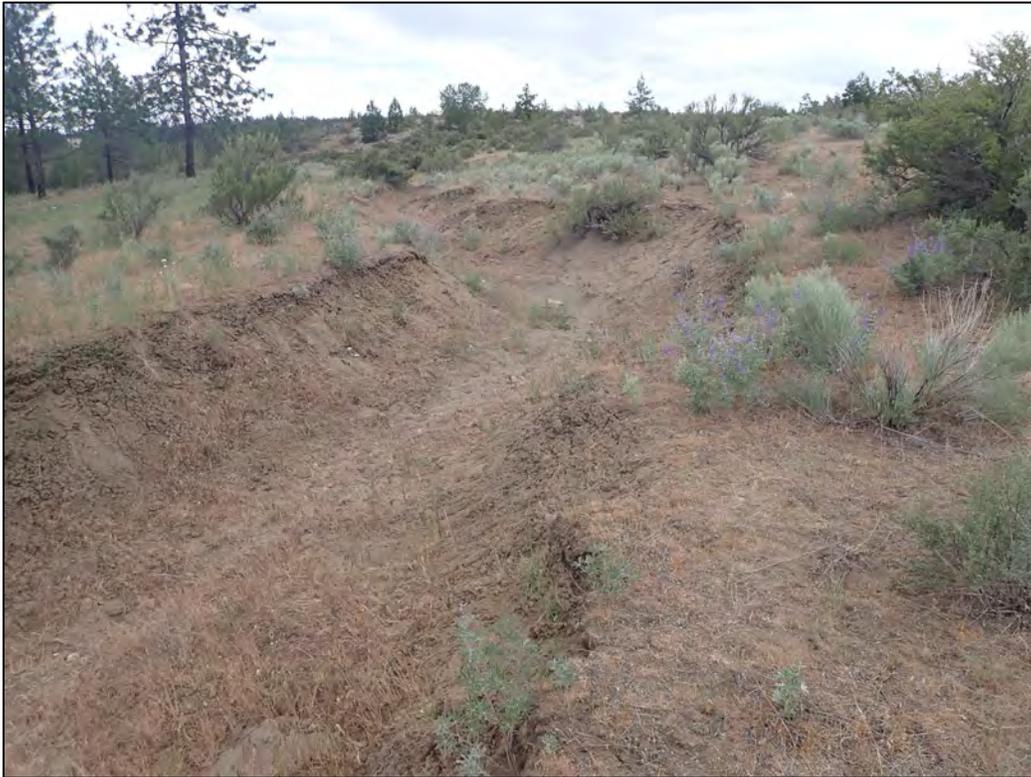
A gully offsite, downgradient of the riprap-armored swale near perimeter sign P1, was first observed in 2009. The gully is photographed periodically to monitor its development (PL-6). Although erosion continues to occur because of site drainage, the gully is not impacting site features or access but will continue to be monitored. Additionally, minor erosion was identified during the 2021 inspection adjacent the two-track on the southeast side of the cell near perimeter sign P2 (PL-7). The erosion areas are not impacting site features or access and will continue to be monitored. No maintenance needs were identified.

PL-6. Gully Downgradient of Riprap-Armored Swale Near Perimeter Sign P1

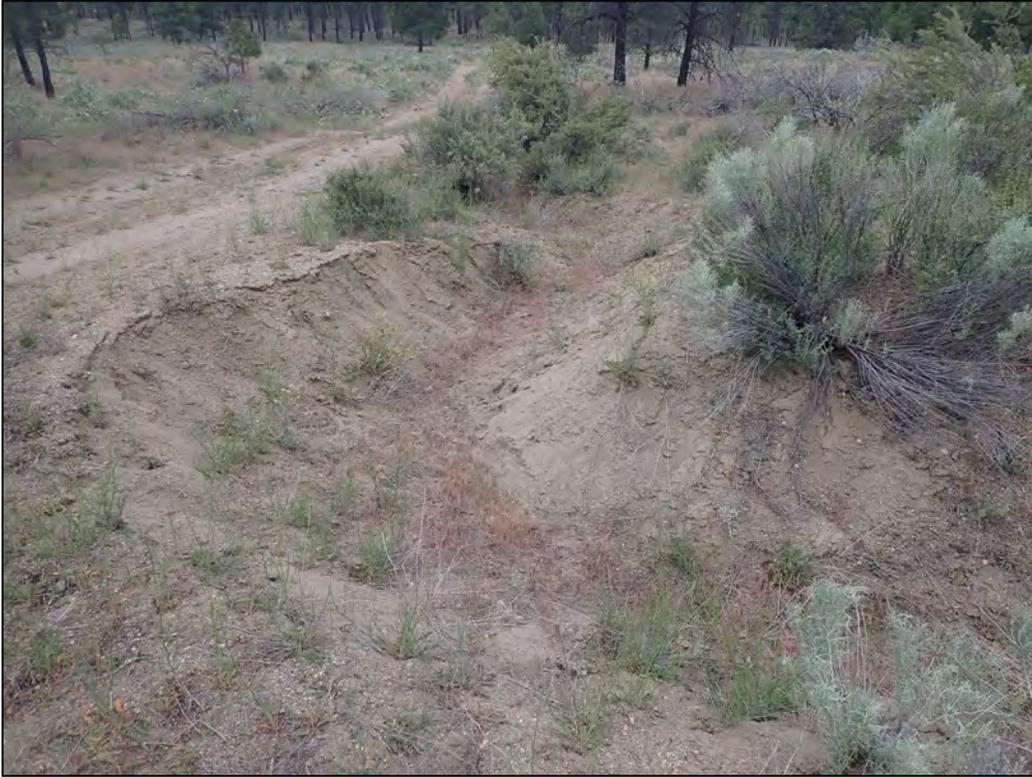
PL-7. Gully Near Perimeter Sign P2 (Stable)

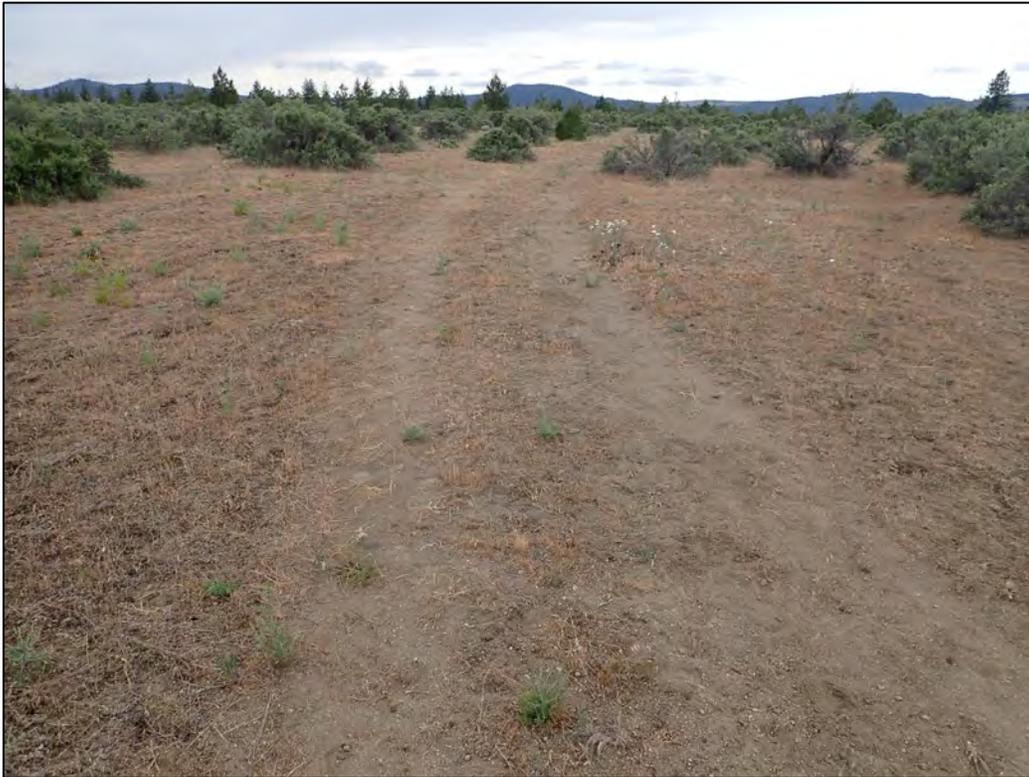
Evidence of vehicle travel was identified on the southwest side of the disposal cell. Minor vehicle tracks were observed from the road intersection near perimeter sign P5 to the edge of Pond 1 (PL-9). The area will continue to be monitored, and strategies to prevent unnecessary vehicle traffic on the cell will be evaluated in consultation with Spokane tribal leadership.

PL-9. Evidence of Vehicle Tracks to Disposal Cell Pond 1

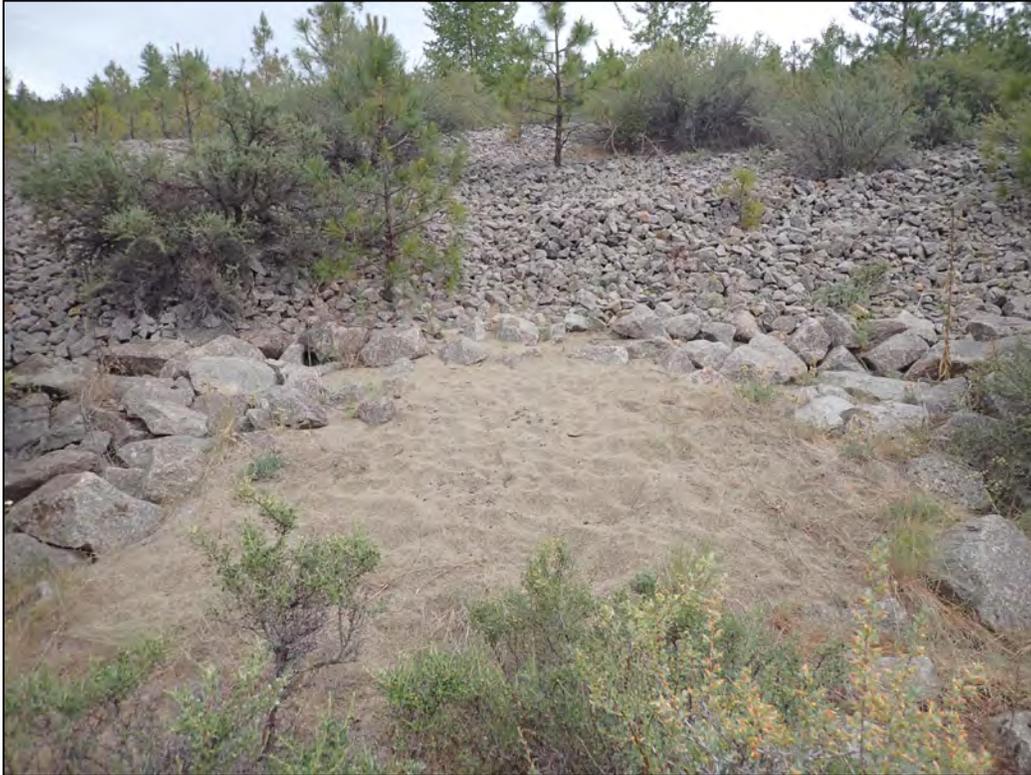
During the 2016 annual inspection, one location at the base of the rock-covered containment dam face was found to have a deposit of sand that had washed out from underneath the rock cover, as evidenced by a shallow rock-filled erosion feature upgradient of the deposit (Figure 5-1). A subsequent follow-up inspection and evaluation identified that the sandy material was the same as natural undisturbed material nearby. During reclamation, this area of the site was used as a source for fill material used to contour the area below the toe of the containment dam. Review of original reclamation and as-built drawings showed that the toe of the containment dam is upslope from the area of erosion, which was confirmed during the follow-up investigations. Therefore, it was concluded that the sand deposit location is in a portion of the dam defined as the outslope in the construction completion report and does not impact the containment dam (DOE 2018b).

The sand deposit location was examined during the inspection, and there was no apparent change in the deposit or the upgradient erosion feature (PL-11). The area will be visually monitored during future inspections and by periodic aerial remote sensing surveys. Repair options will be evaluated and implemented, in consultation with NRC, if the erosion area increases such that the containment dam could be affected.

PL-11. Sand Deposit at Toe of Containment Dam Outslope

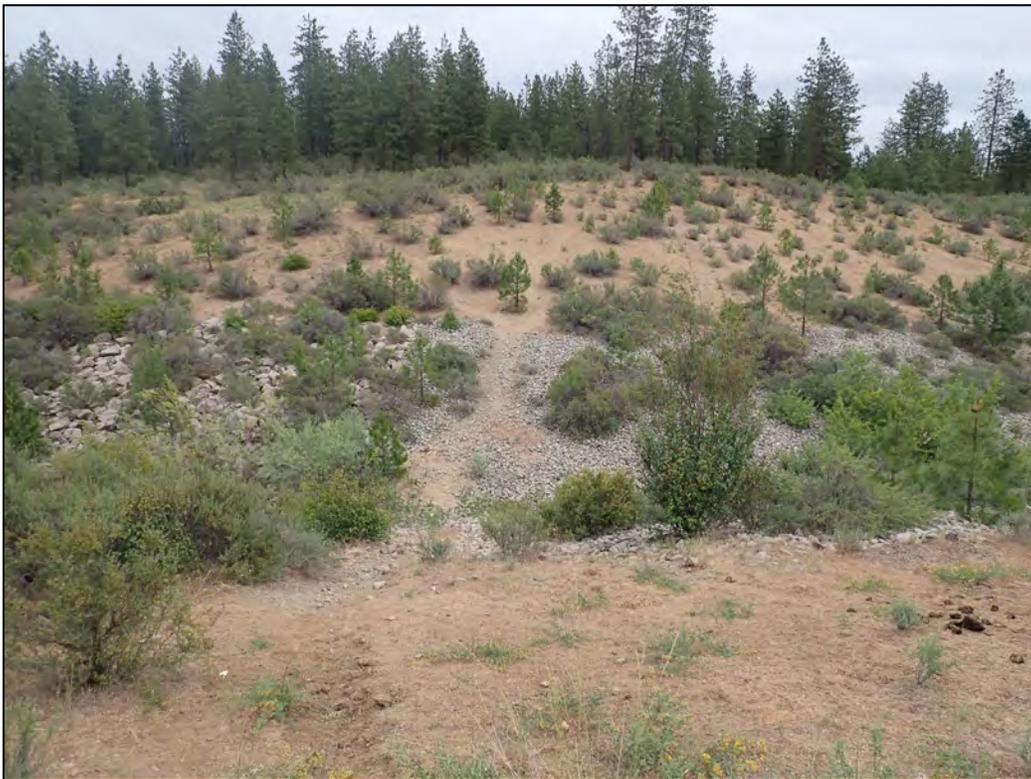
PL-12. Wildlife Trail Adjacent the Disposal Cell

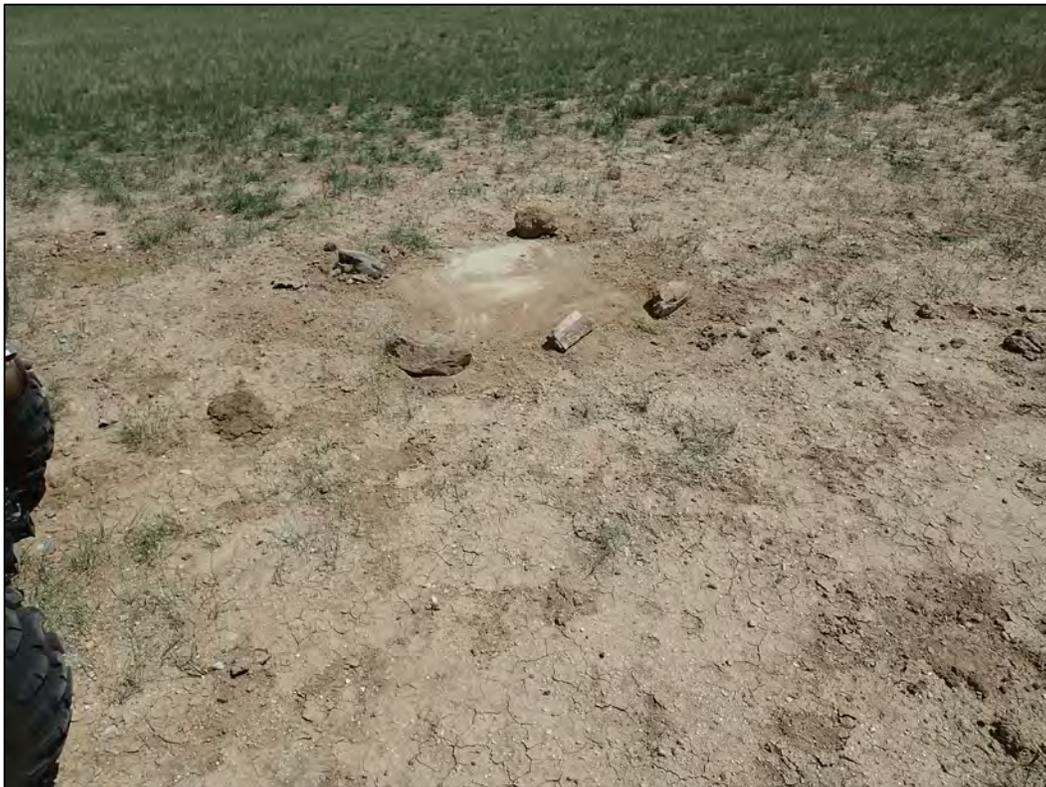
PL-4. Quality Control Monument QC7, Usually Buried Under Soil
